FORENSIC ENGINEERING NEWS AND VIEWS

June 2023

Solenoid Valve Failures – Flooding Your Home

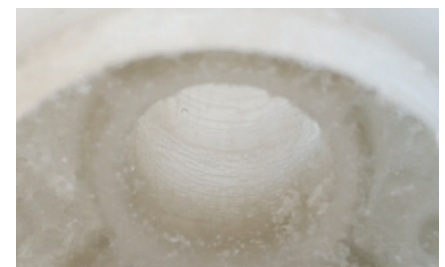
Photograph D

4. **Degradation of the Plastic Valve Body:** The valve's plastic body can degrade over time. This can be exacerbated by the exposure of the plastic to direct sunlight. An example of crazing to a plastic solenoid valve body which resulted in a water loss can be observed in **Photograph D**.

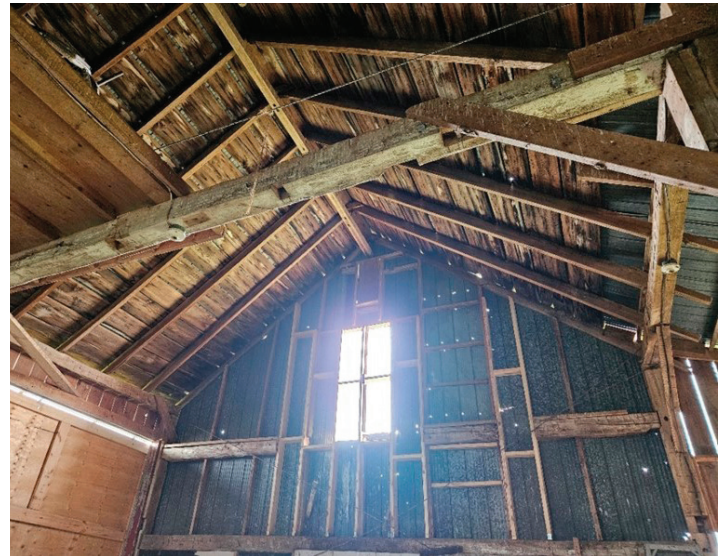
This is where Mass Timber can be used. The beauty of a prefabricated Glued-Laminated (Glulam) beam is that you can dimension it to whatever size you need. 12 x 12 post? That is just a bunch of 2 x 12s glued together. If you need it wider, they can go wider by laying boards side by side (such as a 2 x 8 and a 2 x 6) and offsetting them in each layer. The finished look is smooth and can be painted or coated to match the existing timber if desired. Fire resistance is also very good as there are no gaps between the wood members like in a typical built-up beam. This article is about barns but there are also many old buildings in urban settings with wooden beams inside them that would see a lot of use from glulam beams during a repair. In those cases, aesthetics would be very important.
