FORENSIC ENGINEERING NEWS AND VIEWS

Stave Silo Collapse

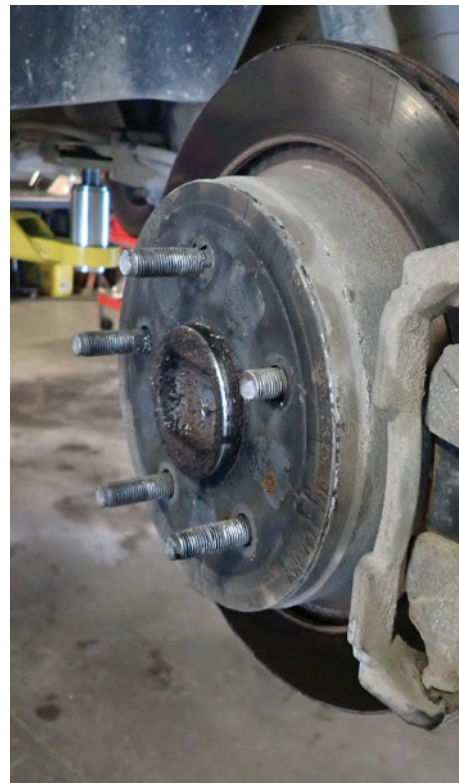
When a lug nut self-loosens the remaining lug nuts are require to bear a greater portion of the wheel's clamping load. This can introduce more vibration into the system which can accelerate the self-loosening of the other fasteners and can result in the overloading of the remaining studs. If this issue is not corrected immediately, the overloaded studs can fail catastrophically, allowing the wheel to separate from the vehicle. We have observed this exact phenomenon occur a number of times. Figure 1 below displays a wheel hub where 4 of the lug nuts were determined to have self loosened.
